EFFECTS OF ENVIRONMENT ON CREEP BEHAVIOR OF NEXTEL

720/ALUMINA-MULLITE CERAMIC COMPOSITE AT 1200°C

THESIS

AFIT/GAE/ENY/08-M11

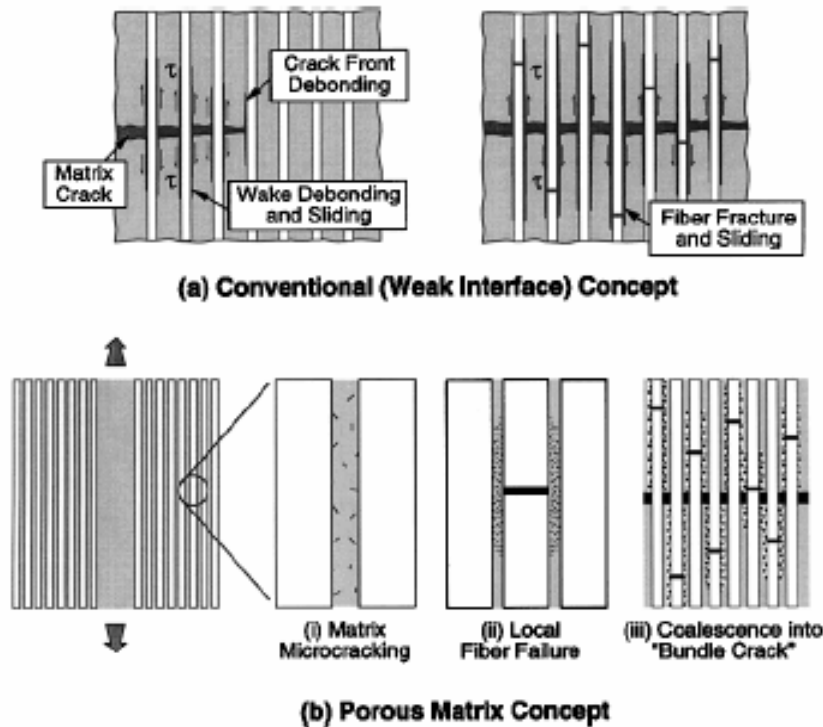
Figure 2. Common CMC damage tolerance mechanisms: (A) Weak fiber/matrix interface and (B) Porous matrix [31].

Damage tolerance in continuous fiber-reinforced ceramic composites is generally achieved in one of two ways (see Figure 2). The first tolerance mechanism utilizes a fiber coating or interphase to mechanically separate the fiber reinforcement from the matrix. The weak interface between fiber and matrix allows cracks to propagate through the matrix, but around the fibers. Downsides of this approach include a relative short supply of the fiber coating materials themselves as well as the complexity of producing coated fibers. The second approach involves the use of a porous matrix with low fracture toughness to achieve the same effect. While porous matrix composites may be easier and

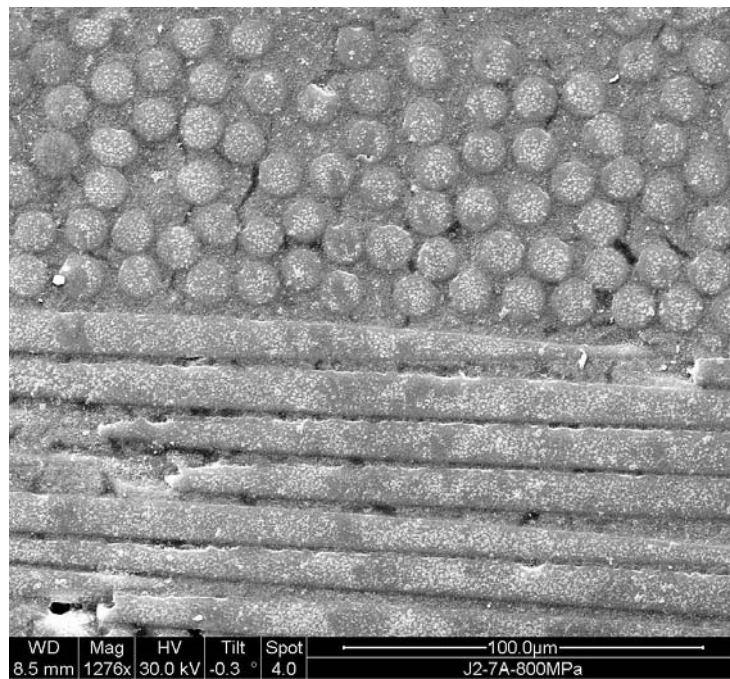
Figure 5. SEM micrograph of virgin N720/AM composite showing 0° and 90° fibers.

Figures 4 and 5 reveal numerous micro-cracks in the matrix of the composite. These cracks are a result of differences in thermal expansion coefficient of the fibers and are not a result of testing. The presence of matrix microcracks in an untested material is typical for porous matrix CMCs. The micrographs in Figures 4 and 5 also show good matrix infiltration between fibers as well as matrix rich areas between fiber tows.

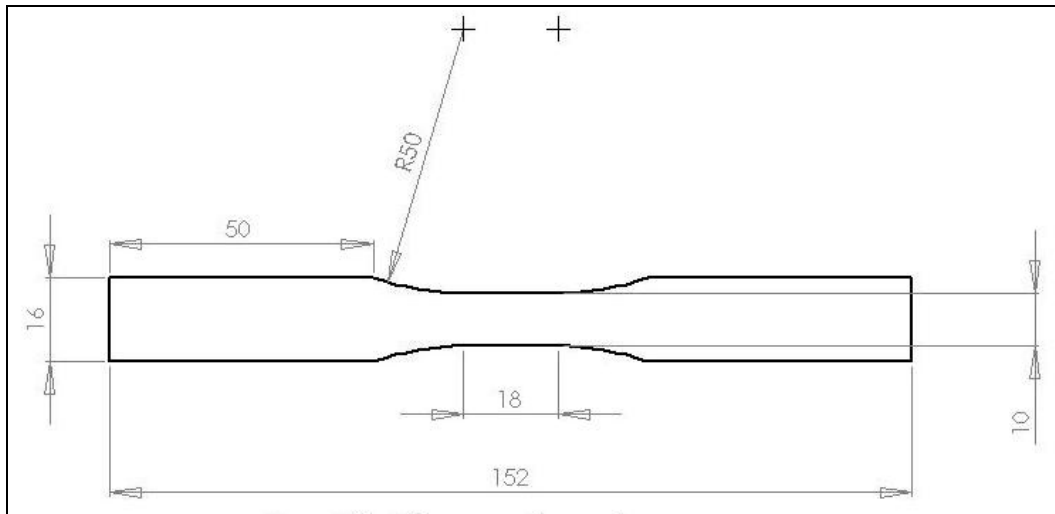
Figure 6. Test Specimen, dimensions in mm.

The Nextel720/Alumina-Mulite specimens used for this research were cut from a 12 x 12 inch panel by the AFIT machine shop using a high pressure waterjet. To prevent edge fraying, the panel was sandwiched between two thin aluminum sheets with double sided adhesive tape. Average thickness of the panel was 3.2 mm. Standard dogbone-shaped specimens were used in all tests. Specimen geometry is shown in Figure 6.

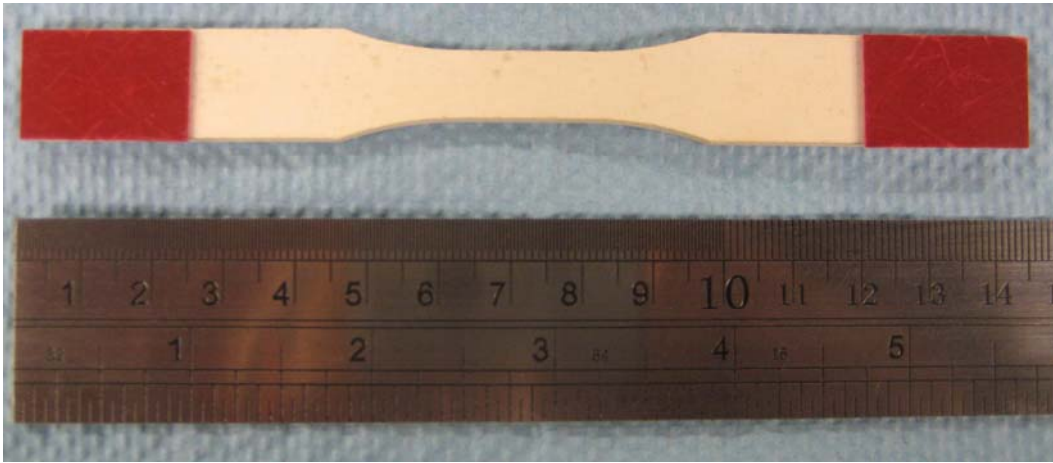
Figure 7. N720/AM tensile specimen with tabs.

The last step in preparing the specimens for testing was to attach fiberglass tabs to the gripping sections. The purpose of the tabs was to protect the specimen against possible surface cracks caused by the grips of the testing machine. The tabs were attached to the specimens using M-Bond 200 adhesive. A specimen with tabs can be seen in Figure 7.

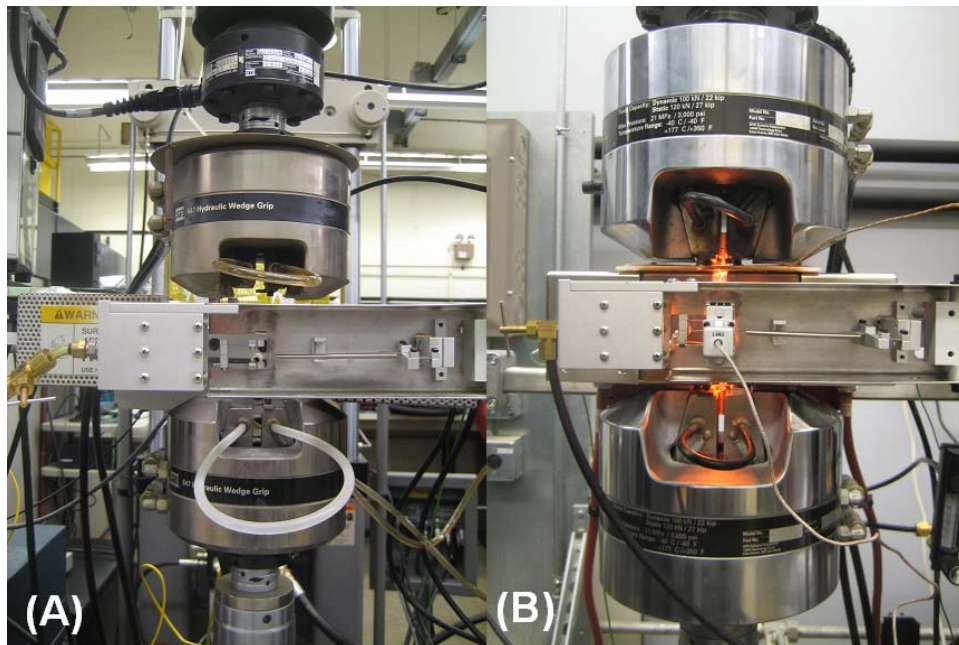
Figure 8. MTS mechanical testing machines: (a) 5 kip and (b) 22 kip.

The second MTS machine had a load cell of 22 kip (98 kN) capacity, and also was equipped with MTS 647 water-cooled hydraulic wedge grips. However the grips used on the 22 kip machine were much larger than those on the 5 kip machine (see Figure 8). Therefore the grip pressure was reduced to 2.5 MPa. The grips were cooled by a NESLAB RTE7 water chiller with water temperature set to 15°C. The 5 kip and 22 kip mechanical testing stations can be seen in Figures 9 and 10, respectively.

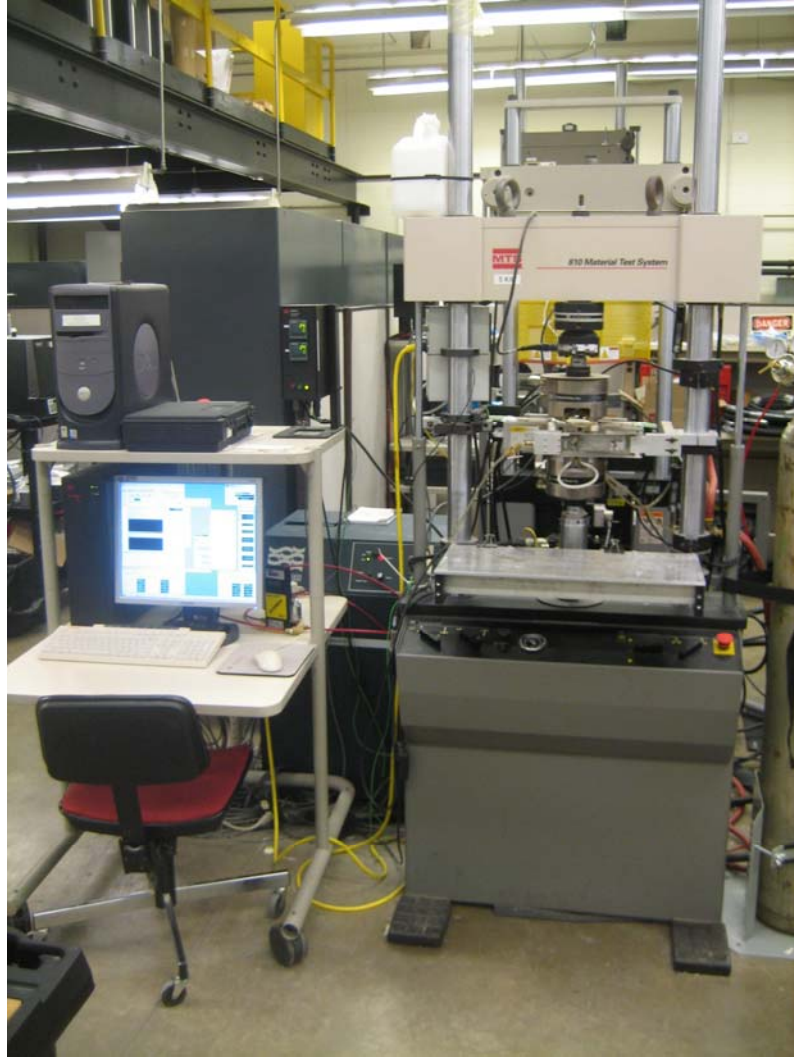
Figure 9. 5 kip mechanical testing station.

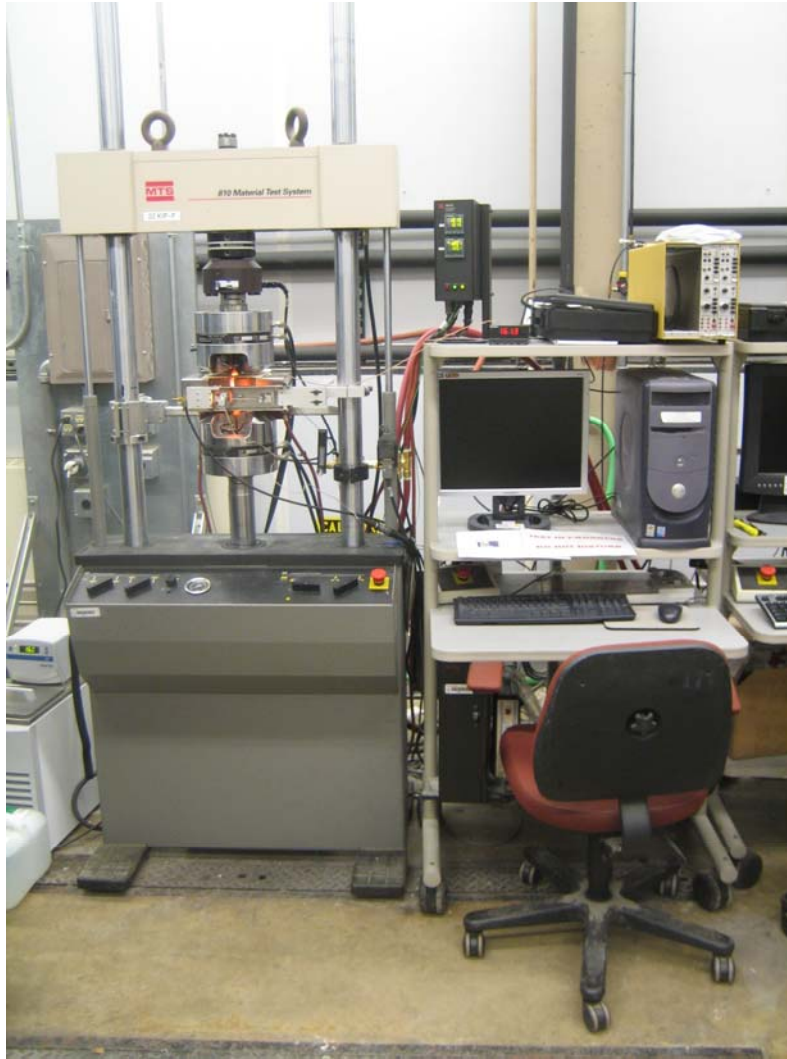
Figure 10. 22 kip mechanical testing station.

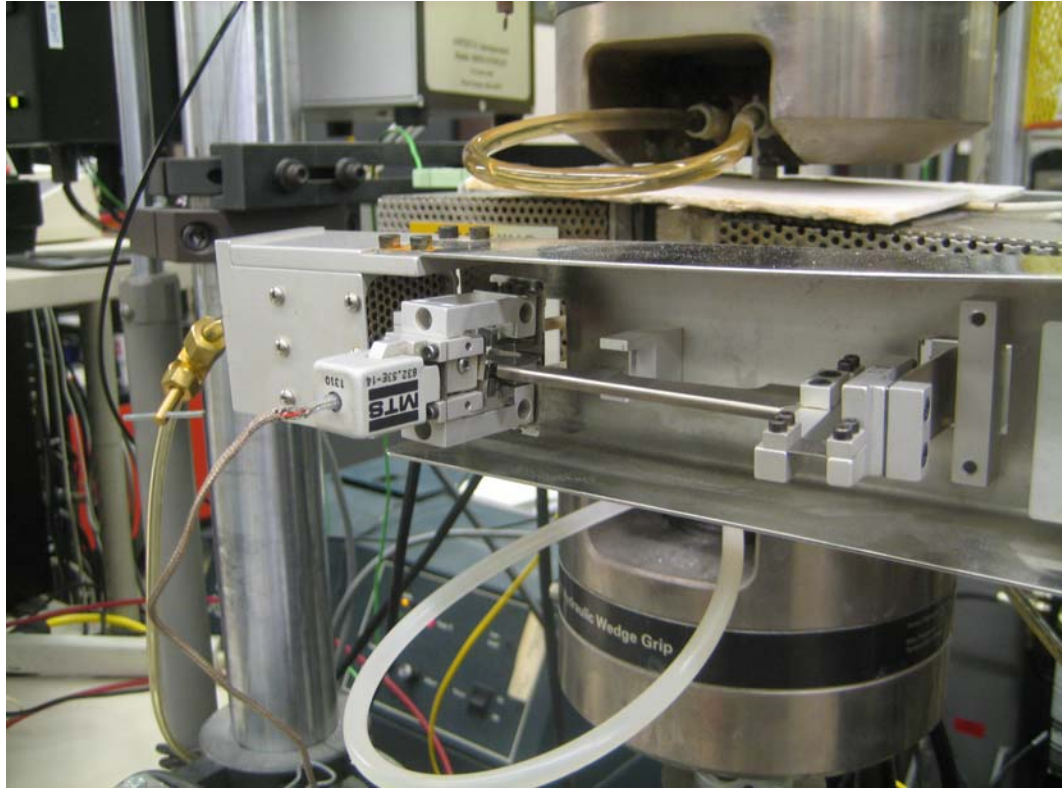
Figure 11. Extensometer platform with heat shield and cooling air.

Strain was measured using high temperature low contact force extensometers manufactured by MTS with a gauge section of 12.7 mm. The extensometer set-up incorporated a heat shield and air cooling system which protected the extensometer from the high temperatures required for this research. The extensometer was calibrated to measure tensile strains up to 20% (see Figure 11).

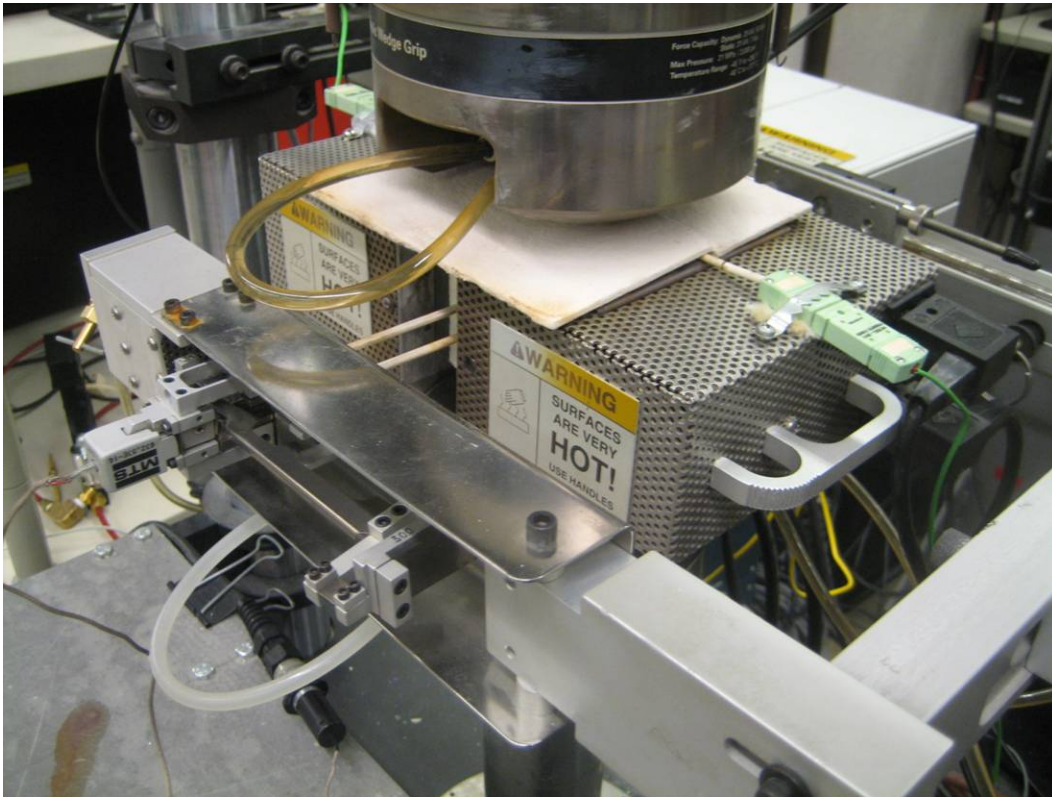
Figure 13. Protective clamshell insulation on the 5 kip machine.

on top of the furnaces (see Figure 13). The furnaces were controlled using MTS 409 Temperature Controllers. Two non-contact internal R-type thermocouples provided feedback to the controller which needed to maintain the desired temperature of the test specimen.

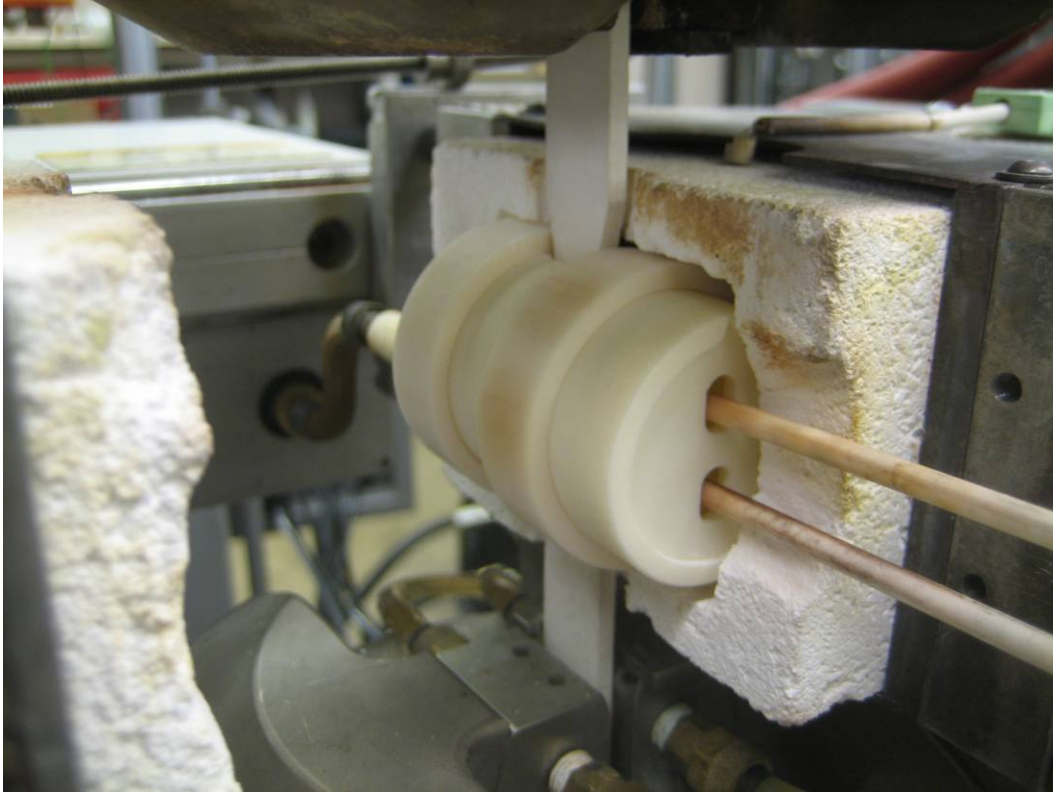
Figure 14. Alumina susceptor and steam feeding tube on the 5 kip machine.

An alumina susceptor was employed for testing in both argon and steam environments. The steam was generated by an AMTECO HRFS-STMGEN steam generation system using deionized water. The steam was pumped through a feeding tube into the back of the susceptor at approximately 30 mL/h. Temperature control on the steam generator was set to 300°F. Testing in argon also required the use of the susceptor. In this case high purity argon was pumped into the susceptor. Flow was regulated using an Omega Mass Flow Controller set to 41 mL/hr. This flow rate ensured all air would be evacuated from the susceptor creating a near 100% argon environment around the gauge section of the specimen. The specimen with a susceptor and gas feeding tube can be seen in Figure 14.

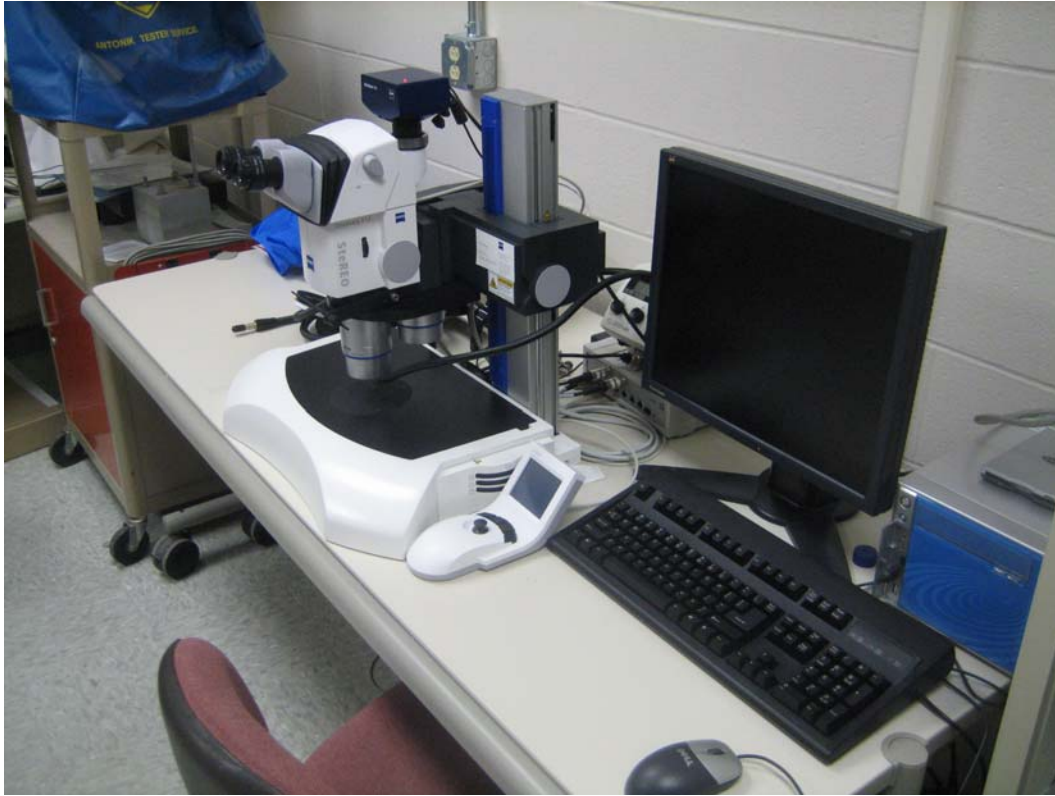
Figure 15. Zeiss Stemi SV II optical microscope.

After the completion of mechanical testing, fracture surfaces were examined using both an optical microscope and a scanning electron microscope (SEM). A Zeiss Stemi SV II optical microscope equipped with a Zeiss AxioCam HRc digital camera and Axiovision version 4.4 software (see Figure 15) was employed. The specimens were also examined using an FEI Quanta 200 SEM shown in Figure 16.

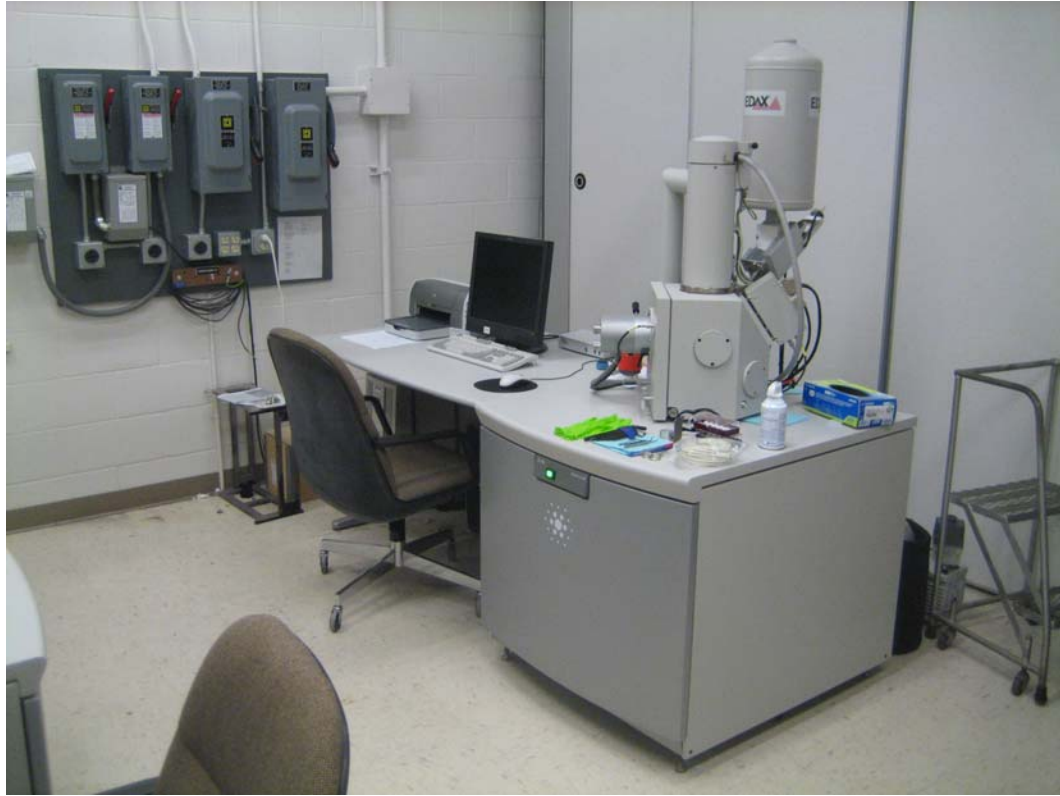
Figure 16. FEI Quanta 200 Scanning Electron Microscope.

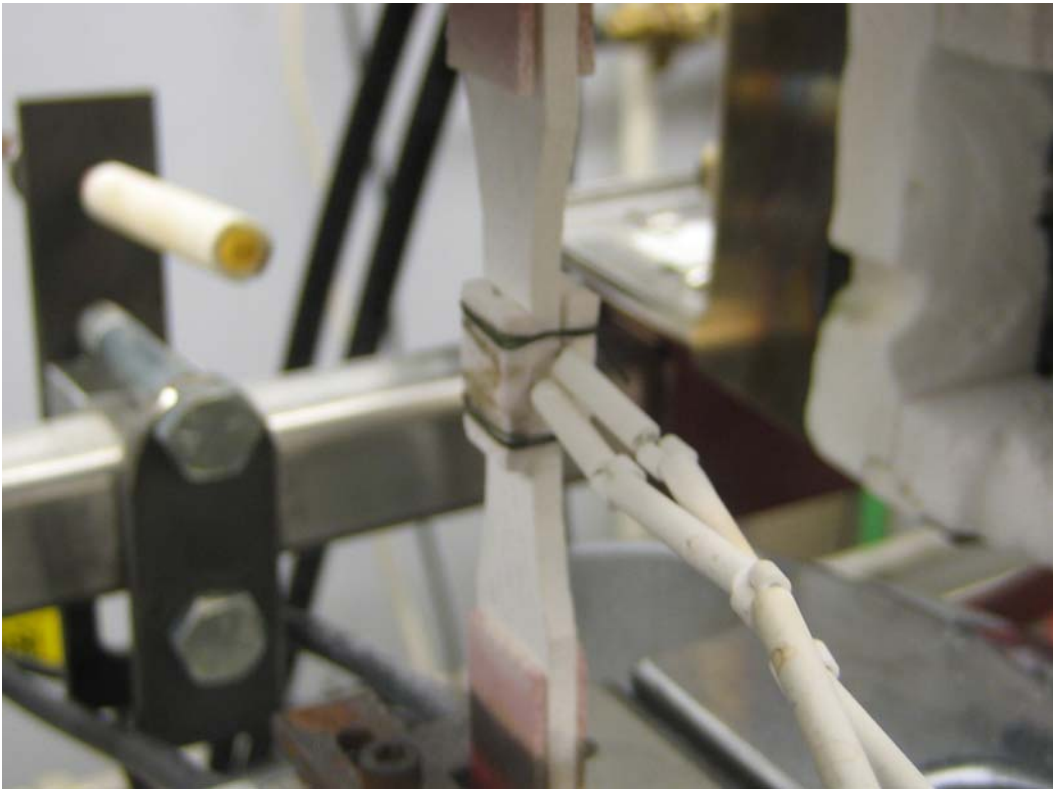
Figure 17. Test specimen instrumented with thermocouples.

All tests were conducted at 1200°C. To calibrate the furnace controllers, a sample was instrumented with two R-type thermocouples. The thermocouples were attached to the specimen by sandwiching them between the specimen and scrap pieces of N720/A on each side. The assembly was then wired together with piano wire to secure the thermocouples in place. This instrumented sample could then be placed in the MTS machine in order to calibrate the ovens to achieve specimen temperature of 1200°C (see Figure 17).

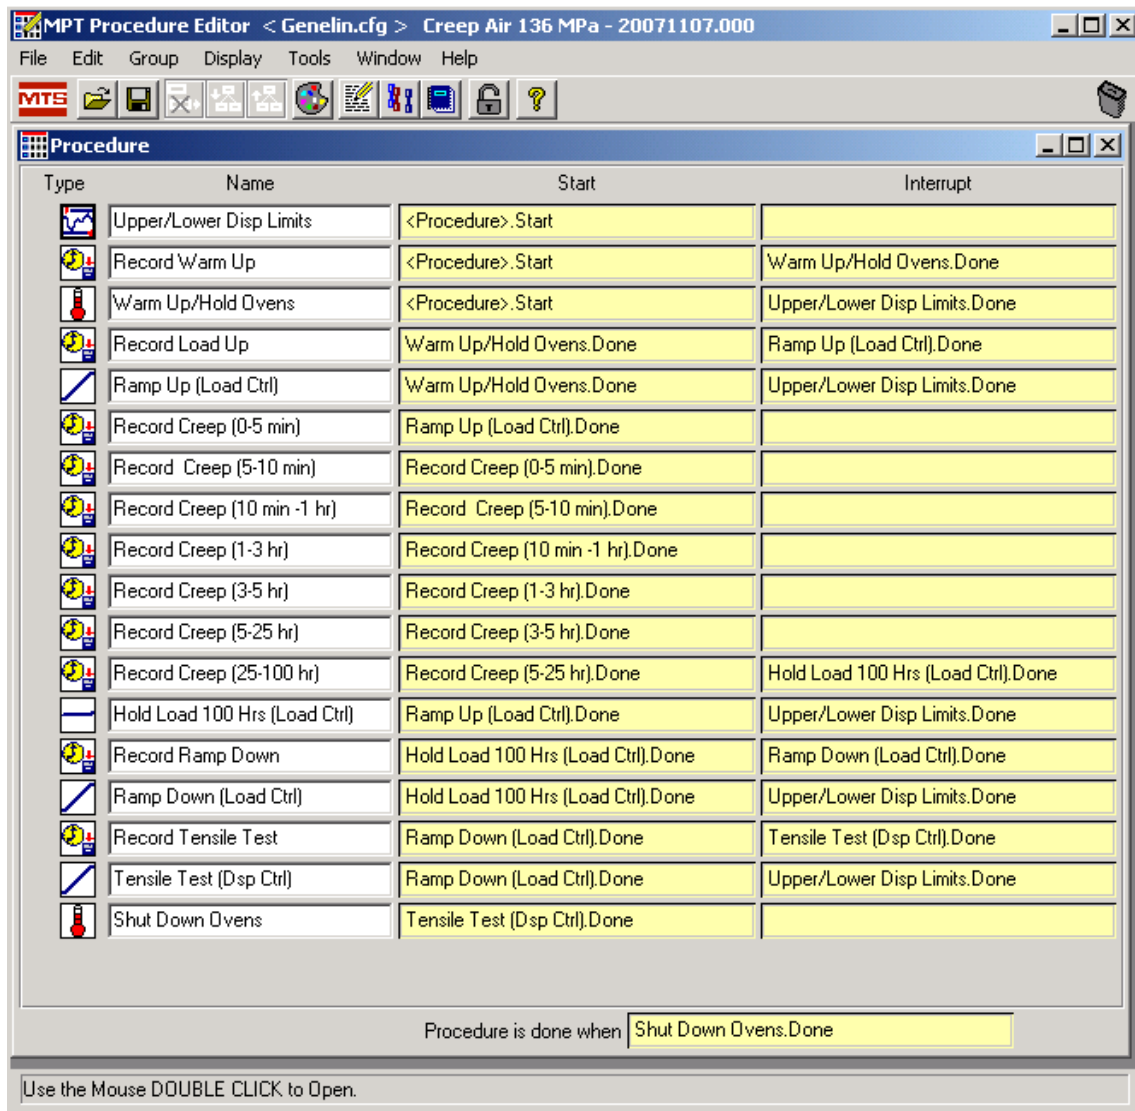
Figure 18. Typical creep test procedure.

back of the susceptor at a rate of 30 mL/minute in the case of steam and at 40 mL/minute in the case of argon expelling the dry air from the susceptor and creating a near 100% steam or a near 100% argon environment inside the susceptor. An example of a typical creep test procedure is shown in Figure 18.

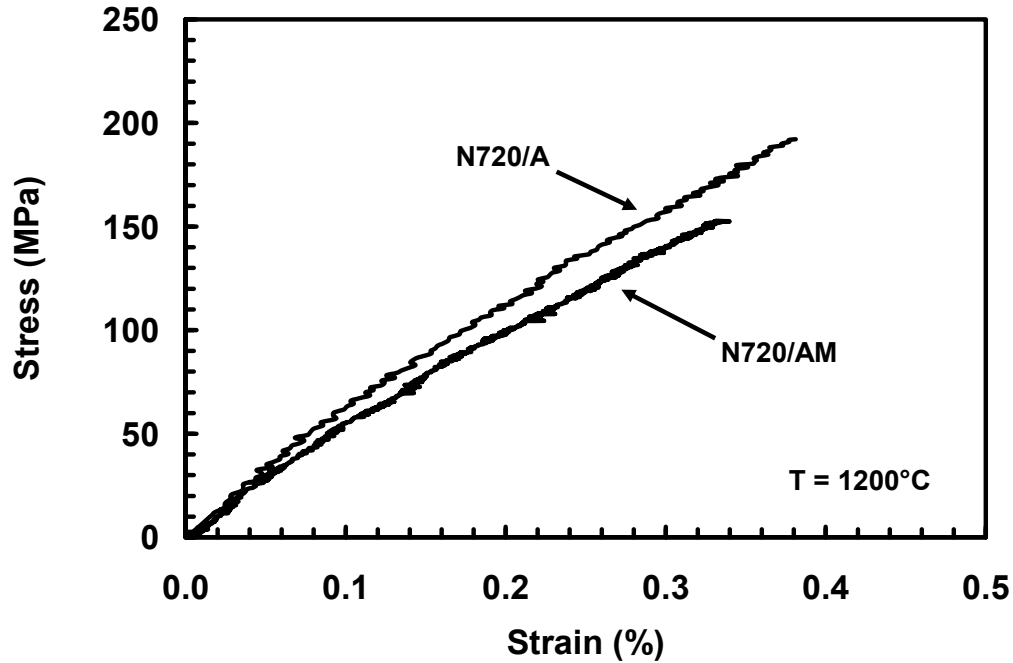
Figure 19. Tensile stress-strain curves for N720/A and N720/AM at 1200°C in laboratory air.

Four monotonic tensile tests were performed at 1200°C in laboratory air. For the N720/AM composite, the average ultimate tensile strength (UTS) was 153.2 MPa, the average elastic modulus, 74.5 GPa, and failure strain, 0.34%. Note that for the N720/A composite, the average UTS was 192 MPa, the average elastic modulus, 75 GPa, and failure strain, 0.38% [13, 23, 18]. Representative stress-strain curves for both composites are shown in Figure 19, where data for N720/A composite is from references [13, 23].

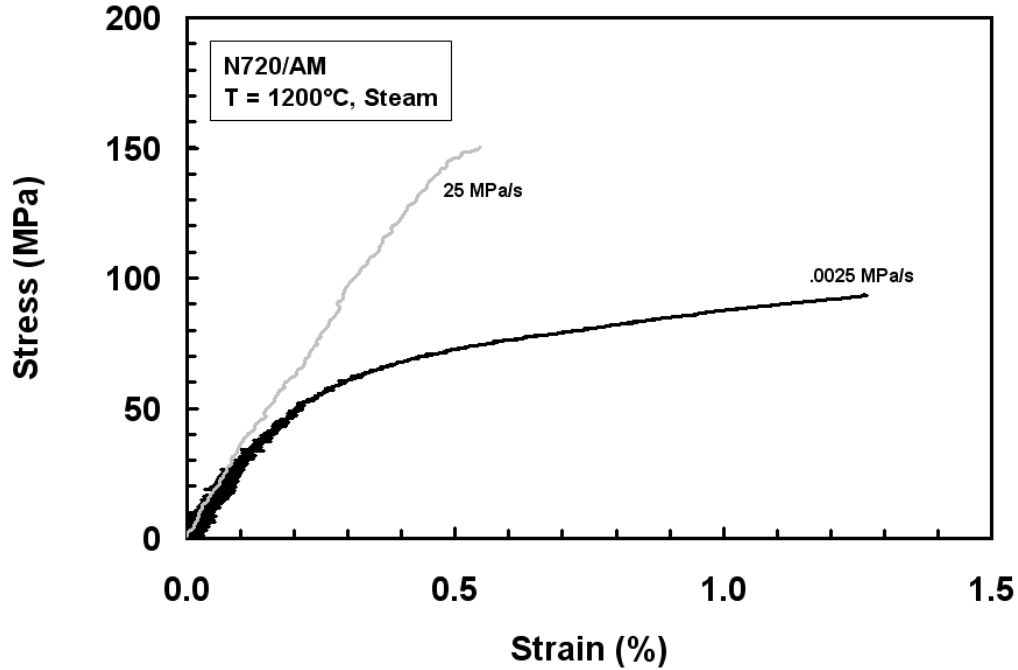
Figure 20. Tensile stress-strain curves for N720/A composite at 1200°C in steam. Dependence of stress-strain behavior and tensile properties on stress rate is evident.

Two N720/AM specimens were also tested in tension to failure at 1200°C in steam. To investigate the effect of stress rate on tensile properties, the stress-controlled tensile tests were conducted at constant stress rates of 0.0025 and 25 MPa/s. Modulus, ultimate tensile strength, failure strain and time to failure are presented in Table 8. Stress-strain curves produced at each stress rate can be seen in Figure 20.

In steam at 25 MPa/s, the tensile modulus was 60.4 GPa, a 19% reduction from the modulus observed from displacement-controlled tensile tests in air. The ultimate tensile strength of the material was 150.4 MPa which is similar to the average UTS measured observed in air (153.2 MPa). Failure strain increased by 62% when compared to displacement-controlled tensile tests in air and the specimen failed after just 0.0016 h.

tension at a load 38% lower than the 25 MPa/s test. Failure strain for the 0.0025 MPa/s tensile test increased by 130% when compared to the 25 MPa/s test.

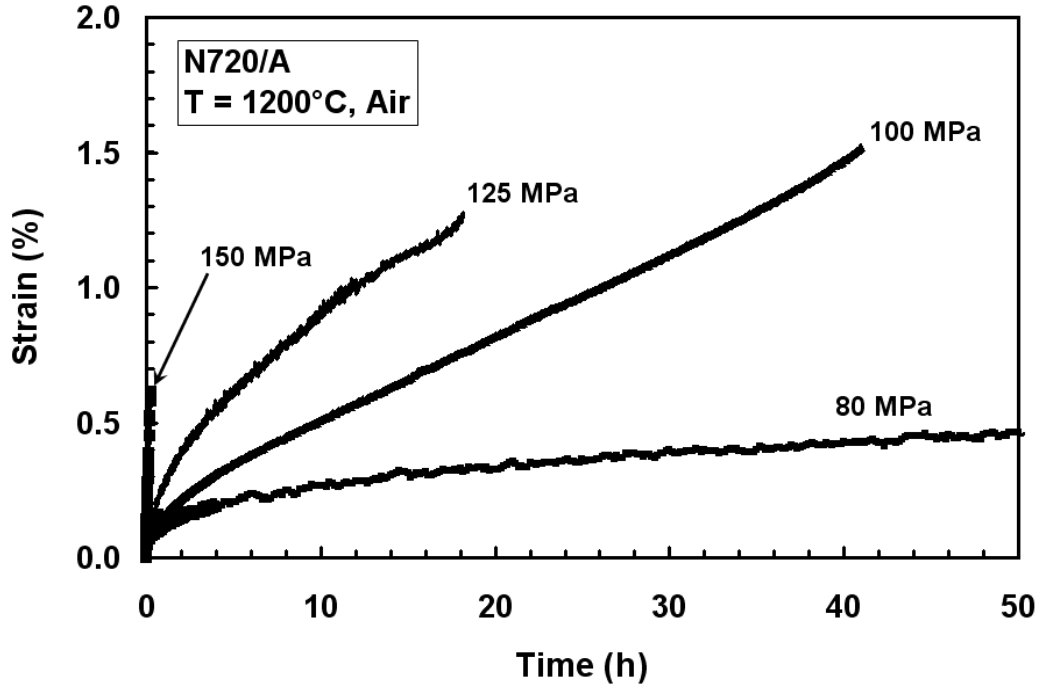
Figure 21. Creep vs. time curves for N720/A composite obtained at 1200°C in air. Data from references [13, 23].

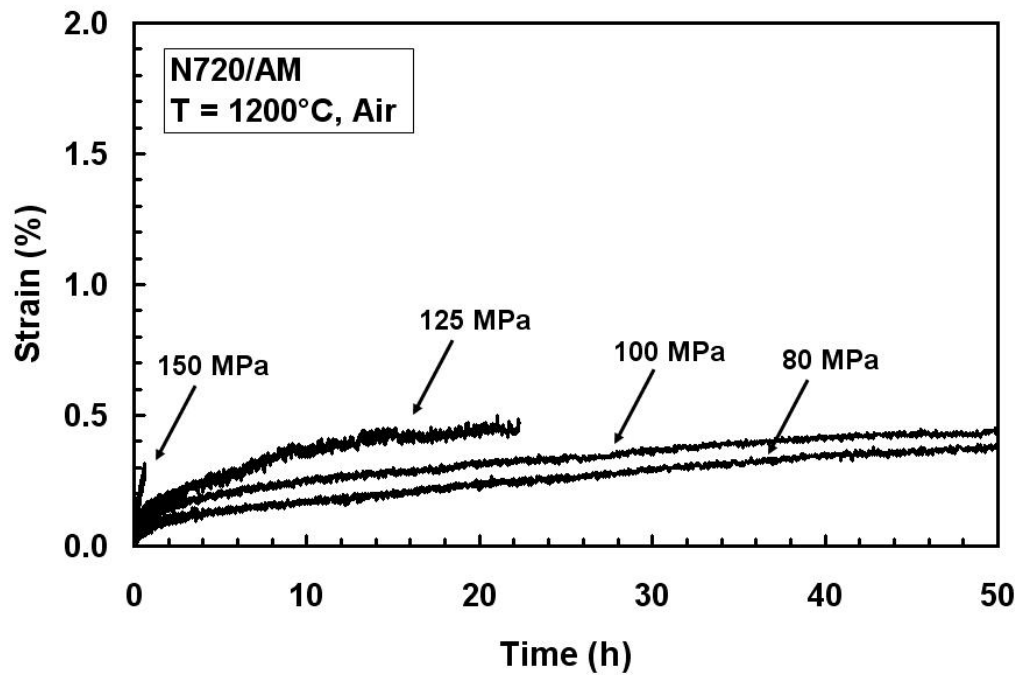
Figure 22. Creep vs. time curves for N720/AM composite obtained at 1200°C in laboratory air. Stress levels equivalent to $V_f = 0.44$ are shown on labels.

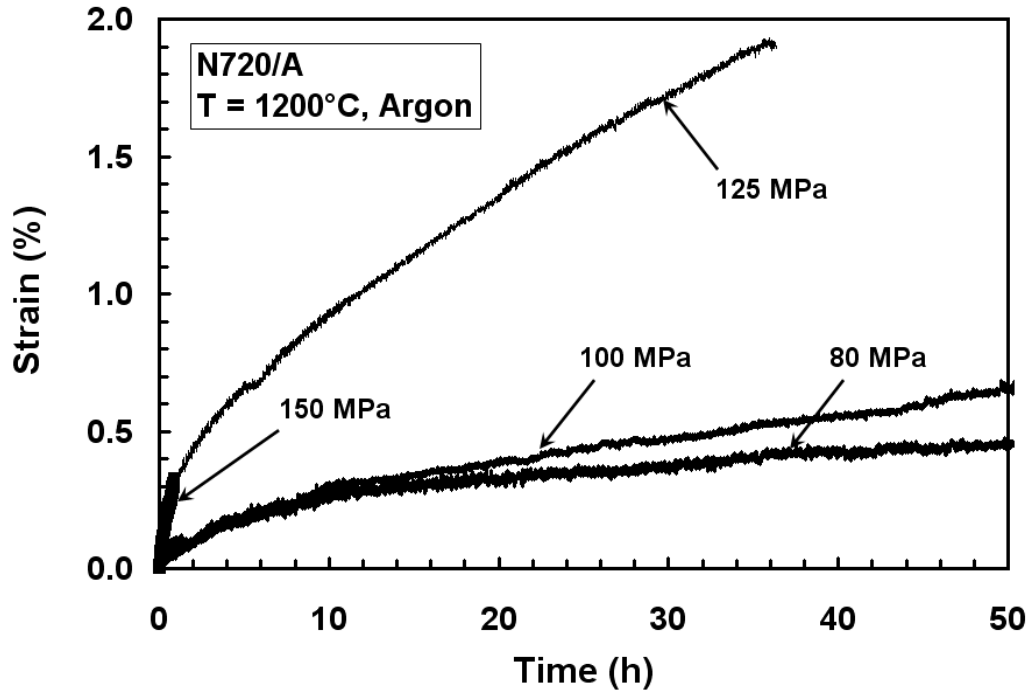
Figure 23. Creep vs. time curves for N720/A composite obtained at 1200°C in argon. Data from references [24, 15].

Figures 23 and 25 show that test environment has little effect on the appearance of the creep curves obtained for the N720/A composite. Creep curves and creep strains obtained in air are comparable to those produced in argon and in steam. However, this was not the case for the N720/AM CMC. While creep curves produced in argon did exhibit both primary and secondary creep regimes, in argon the transition from primary to secondary creep occurred much earlier in creep life at the two lowest stress levels. At 114 and 136 MPa, transitions from primary to secondary creep occurred after ~ 23 and 36% of the creep life, respectively. For all stress levels in argon, secondary creep continued until failure. Creep strains for N720/AM obtained in argon were 2 to 9 times higher than those obtained in air. Moreover, in argon creep strains decreased with increasing creep stress. For creep stress levels of 73 and 91 MPa, creep strain made up approximately 95% of the total strain. For 114 MPa, creep strain accounted for nearly 75% of total strain. For 136 MPa, creep strain approached 53% of the total strain. Creep curves for N720/AM produced at 1200°C in argon are presented in Figure 24.

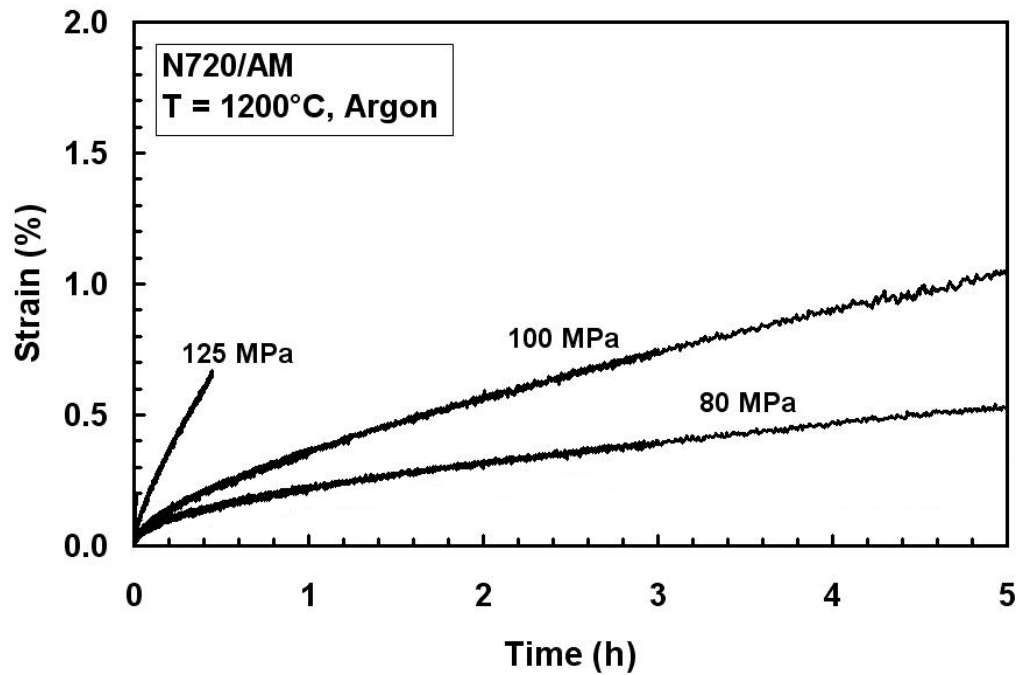
Figure 24. Creep vs. time curves for N720/AM composite obtained at 1200°C in argon. Stress levels equivalent to $V_f = 0.44$ are shown on labels.

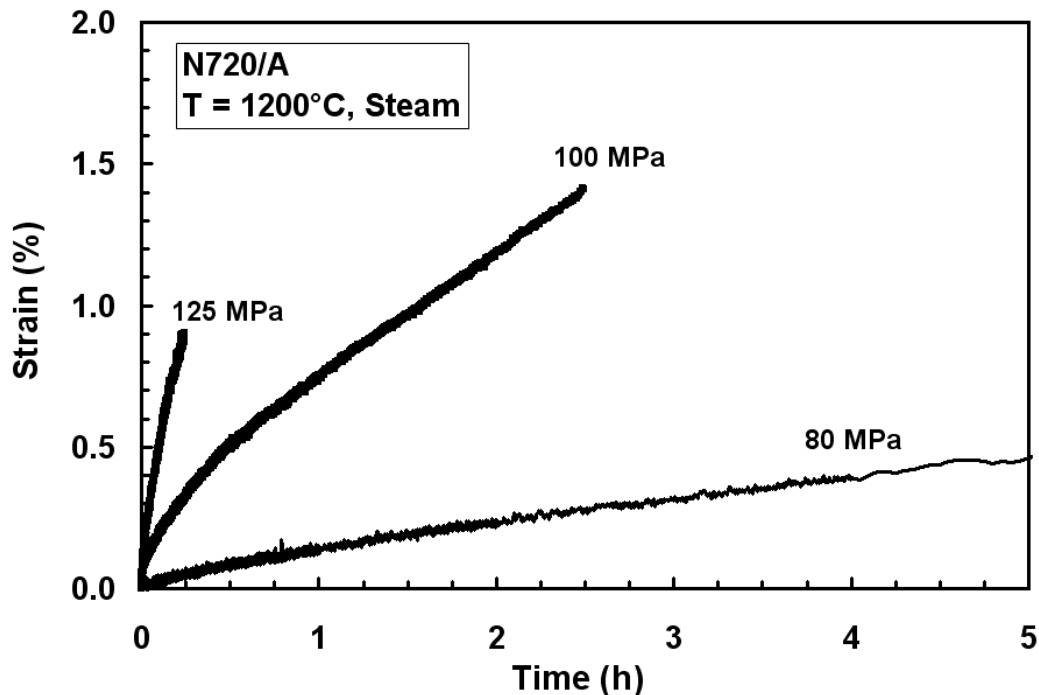
Figure 25. Creep vs. time curves for N720/A composite obtained at 1200°C in steam. Data from Reference [13, 23].

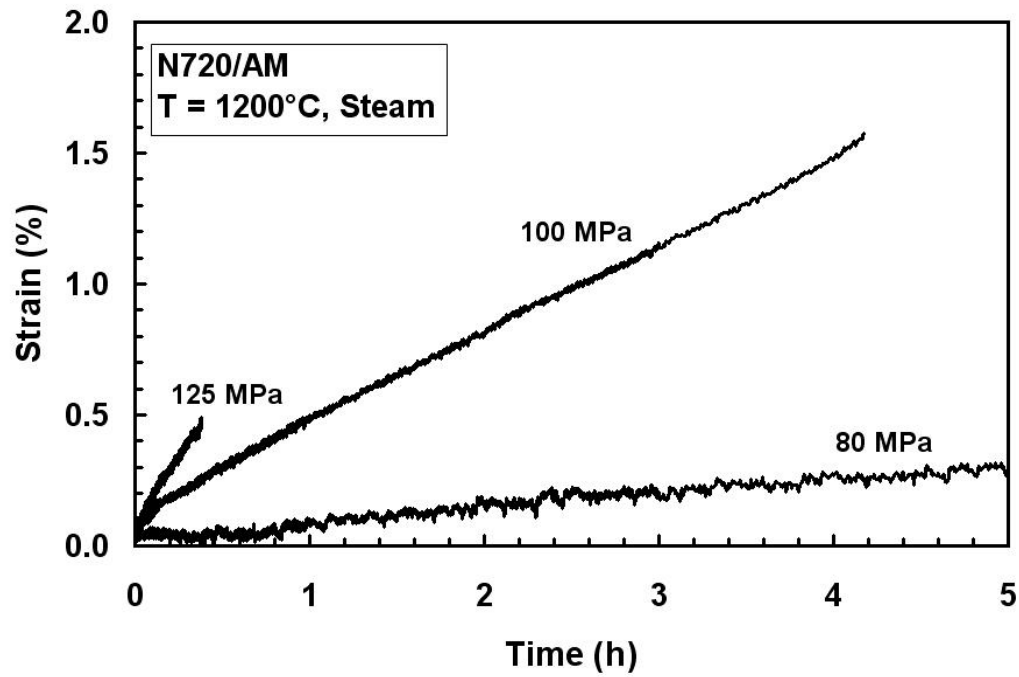
Figure 26. Creep vs. time curves for N720/AM composite obtained at 1200°C in steam. Stress levels equivalent to $V_f = 0.44$ are shown on labels.

Creep curves for the N720/AM obtained at 1200°C in steam also differ significantly from those produced at 1200°C in air (see Figure 26). Primary and secondary creep regimes were obtained in all tests. Primary, secondary and tertiary creep were observed at 73 MPa (see Figure 27). At 73 and 91 MPa primary creep transitioned into secondary creep after approximately 5% of creep life. At 114 MPa transition occurred after 15 % and at 136 MPa the transition was almost immediate. The transition for the 150 MPa case was almost immediate. In the case of the 73 MPa creep test in steam, the N720/AM composite transitions to tertiary creep fairly early in creep life. Creep strains account for 25 to 95% of total strain and decrease with increasing creep stress. Creep strains produced in steam are approximately two times those produced in argon.

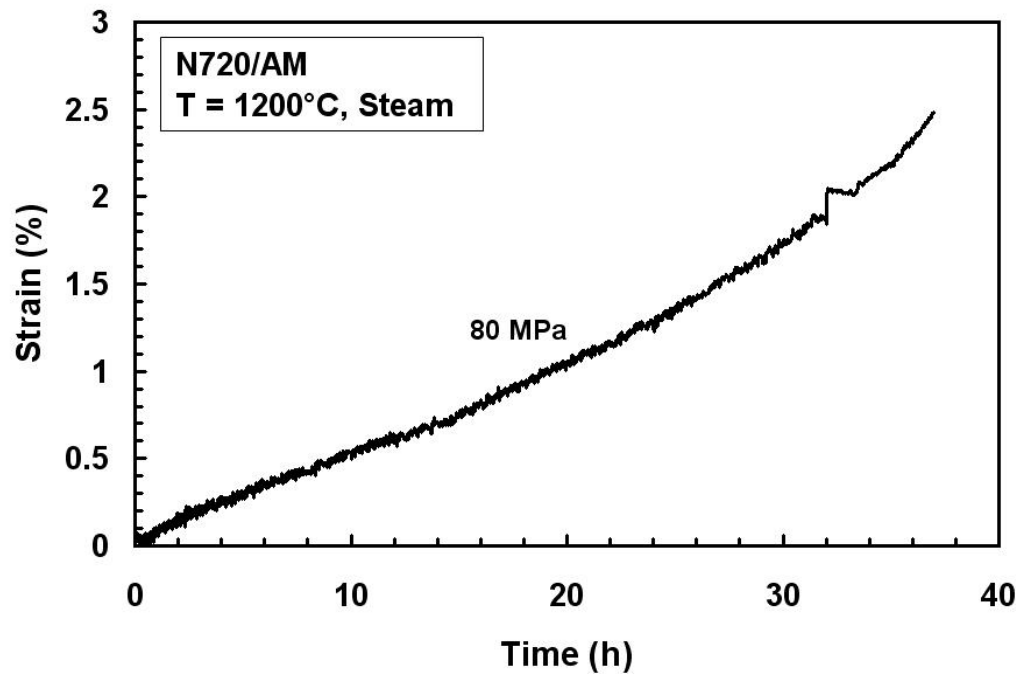
Figure 27. Creep vs. time curve for N720/AM composite obtained at 1200°C in steam. Stress level equivalent to $V_f = 0.44$ is shown on label.

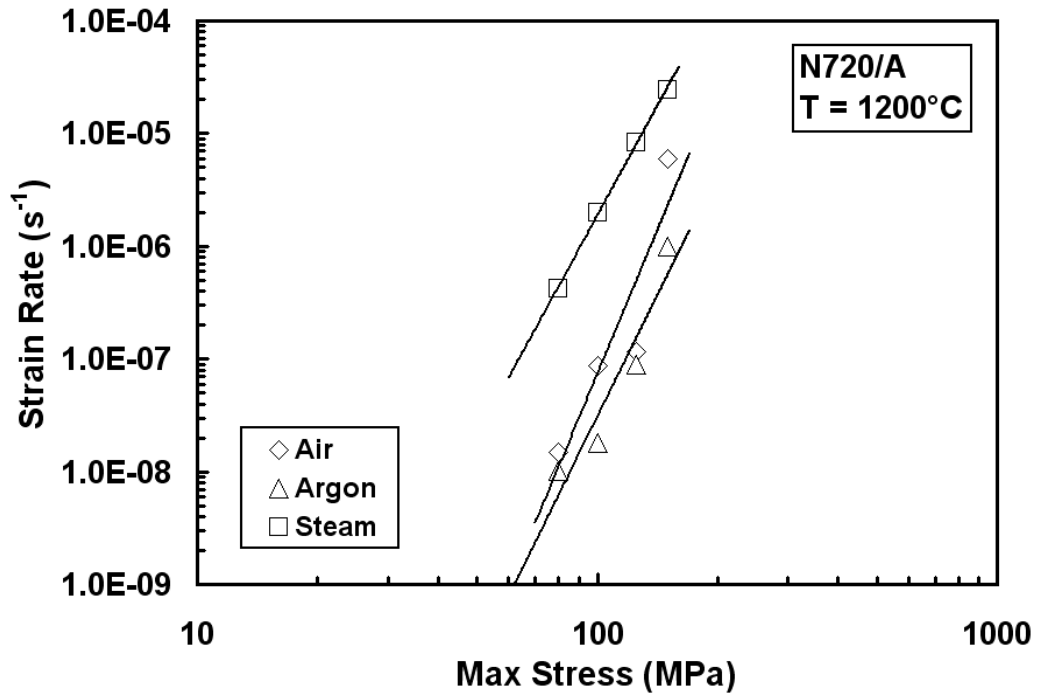
Figure 28. Secondary creep rate as a function of applied stress for N720/A composite at 1200°C in air, argon and steam. Data from references [13, 23, 24, 15].

Minimum creep rate was reached in all tests. Creep rate as a function of applied stress for both the N720/A and N720/AM composites is presented in Figures 28 and 29, respectively. Data for the N720/A composite from references [13, 23, 24, 15] are included for comparison. In air, secondary creep rates for the N720/A can be nearly 10 times those of the N720/AM CMC. In steam, the secondary creep rates of N720/A are two times those of the N720/AM composite. However in argon, secondary creep rates of the N720/A composite are similar to those produced in air, while creep rates produced by the N720/AM CMC are similar to those produced in steam. At 80 MPa (equivalent to 73 MPa for $V_f = 0.40$), creep strain produced in steam for the N720/A was 5 times that obtained in air. For the N720/AM composite creep strain accumulated at 73 MPa in steam was also nearly 5 times that obtained in air. However for N720/AM creep strain produced in argon was nearly 10 times produced in air. At 91 MPa (equivalent to 100 MPa for $V_f = 0.40$), creep strain in argon remained 5 times that obtained in air at the same stress level. While both composites achieved runout in air at the two lowest stress levels, only the N720/A CMC achieved a 100 h run-out in argon (80 and 100 MPa). Neither material achieved runout in steam [23].

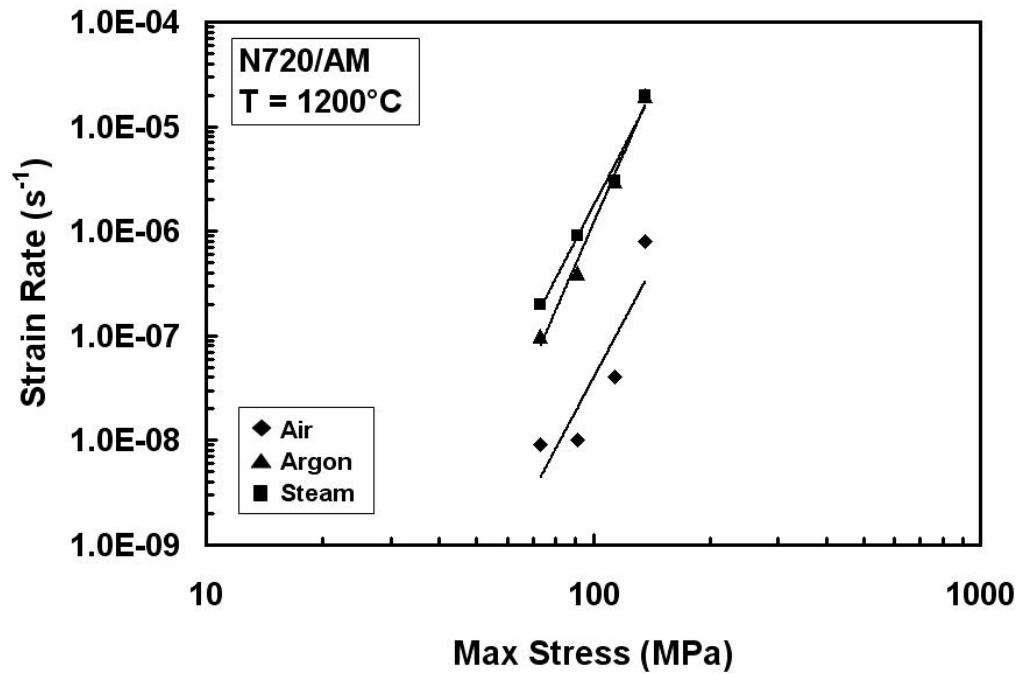
Figure 29. Secondary creep rate as a function of applied stress for N720/AM composite at 1200°C in air, argon and steam. Stress adjusted to $V_f = 0.44$.

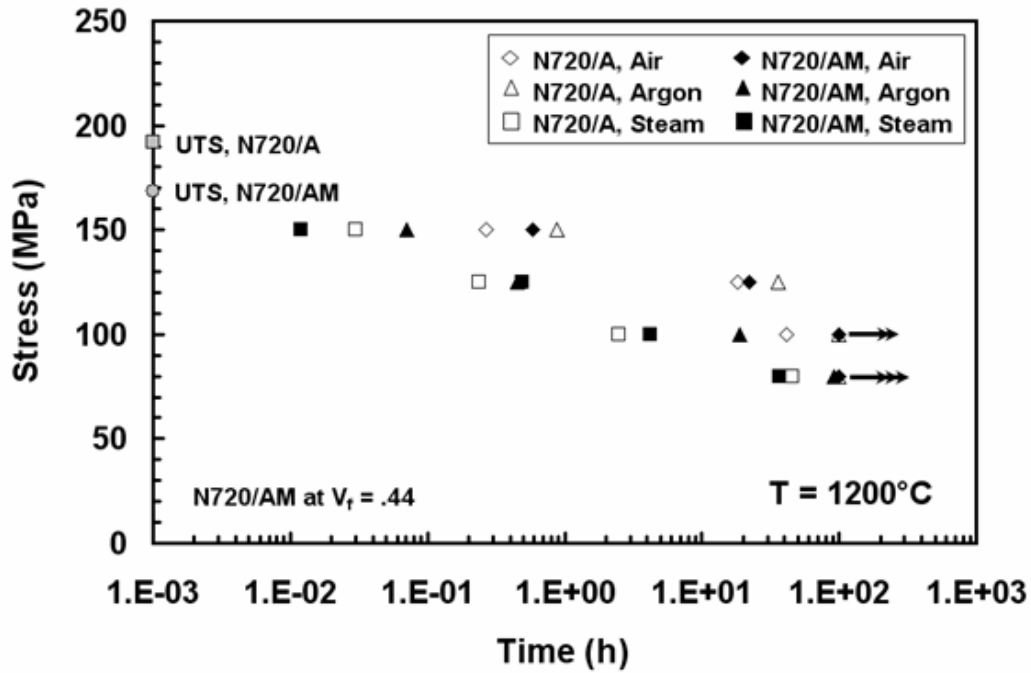
Figure 30. Applied stress vs. time to failure for N720/A and N720/AM ceramic composites at 1200°C in air, argon and steam. Data for N720/A from references [13, 23, 24, 15]. Stress adjusted for $V_f = 0.44$.

Stress-rupture behaviors of both composites are summarized in Figure 30. It is seen that creep life of both composites decreases with applied stress. While the presence of argon had a beneficial effect on creep lifetimes for the N720/A composite, it degraded the creep lifetimes of the N720/AM composite. For stress levels ≥ 100 MPa (equivalent to 91 MPa for $V_f = 0.40$), creep lifetimes of the N720/A in argon were nearly double the lifetimes in laboratory air. For stress levels ≥ 125 MPa (equivalent to 114 MPa for $V_f = 0.40$), creep life in argon for the N720/AM was nearly as short as that in steam. Only at the lowest stress level did the N720/AM composite come close to achieving a run out at 1200°C in argon. The reduction in creep life due to steam was at least 90% for applied stress levels ≥ 100 MPa, and 54% for the applied stress of 80 MPa for N720/A [23]. For N720/AM, the loss of creep life due to steam was greater than 95% for stress levels ≥ 91 MPa (equivalent to 100 MPa for $V_f = 0.44$) and 63% at a stress level of 73 MPa (equivalent to 80 MPa for $V_f = 0.44$).
